# YTHAN DSFB HABITAT IMPROVEMENT PLAN 2025

*Draft for Approval*

### Walkover Survey Assessing Abstraction and Fish Passage Concerns on behalf of the Ythan DSFB

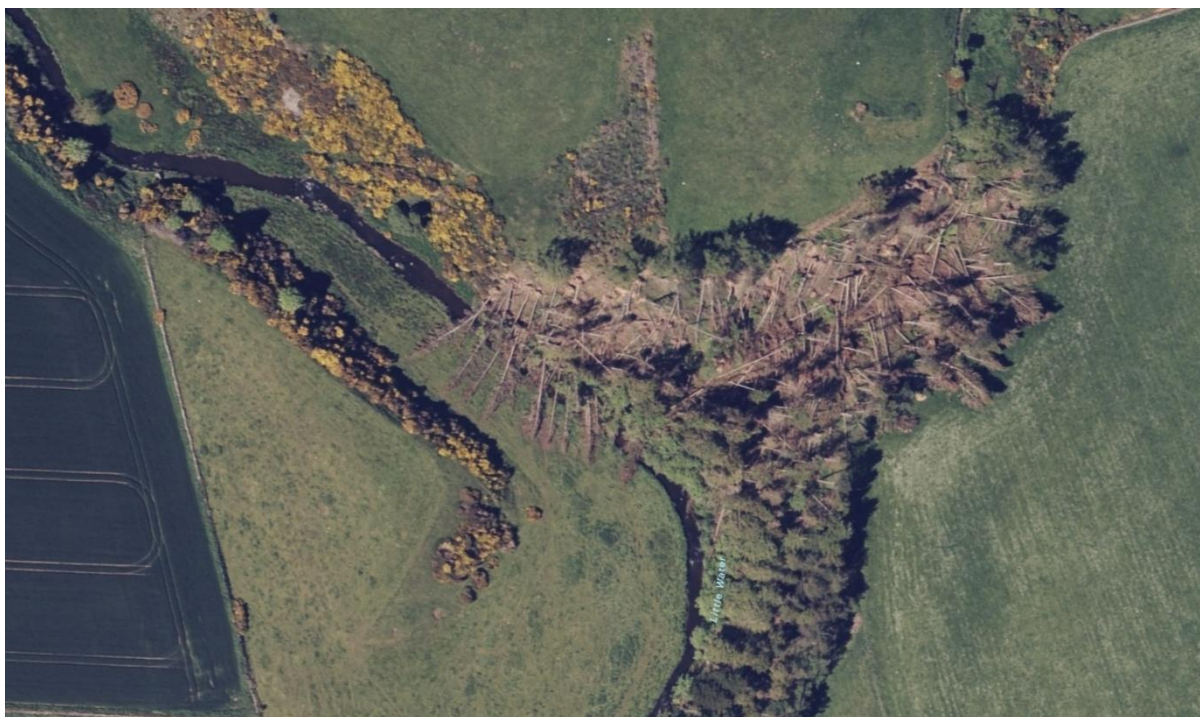
- **Seggat:** A windblown tree has been identified.
- **Fourdon Burn:** Four trees bridging the watercourse require evaluation.
- **Little Water:** Satellite imagery has identified a large quantity of windblown trees, figure 1.

Figure 1. Aerial view of windblown trees for investigation on the Little Water.

These sites will be assessed to determine whether they pose risks to fish passage. If necessary, partial easing will be conducted, while naturally occurring large woody structures (LWS) will be left intact unless they obstruct migration. Additionally, manmade debris (e.g., fencing materials, plastics) will be removed to prevent blockage formation.

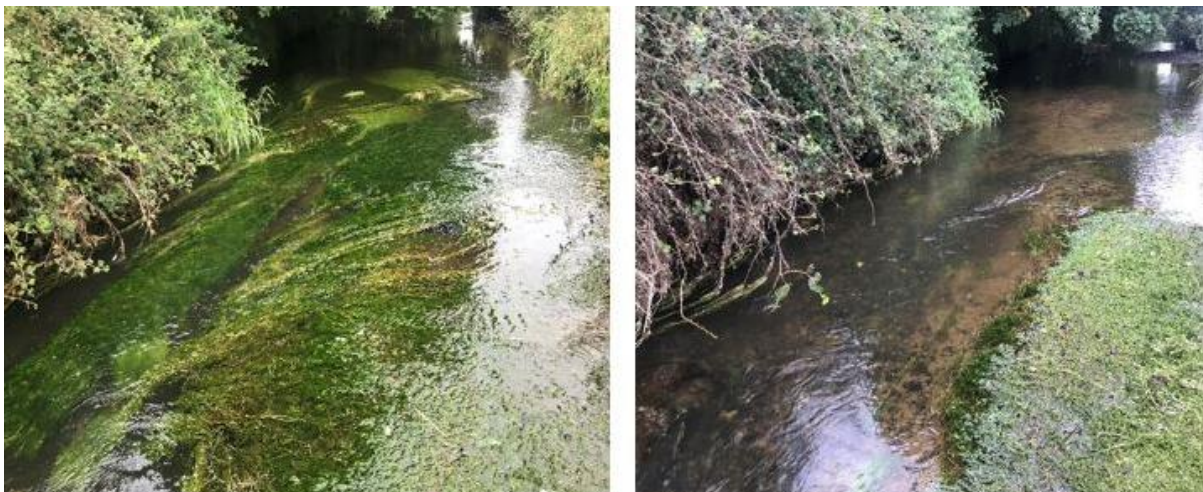
In 2024, Ranunculus clearing was conducted at 10 sites along a 5 km stretch from Drumwhindle Bridge to Glenebrie Bridge. Ranunculus weed growth had smothered areas of suitable spawning gravels. Following weed clearing these spawning sites were restored allowing salmon and trout to access weed free spawning gravel as illustrated in figures 2 and 3 below.

Figure 2 & 3. Before and After images of ranunculus removal.

A long-term solution could involve tree planting along the Ebrie Burn to provide shade and naturally reduce Ranunculus growth. Key planting locations identified through the habitat surveys carried out in 2023 could be utilised.

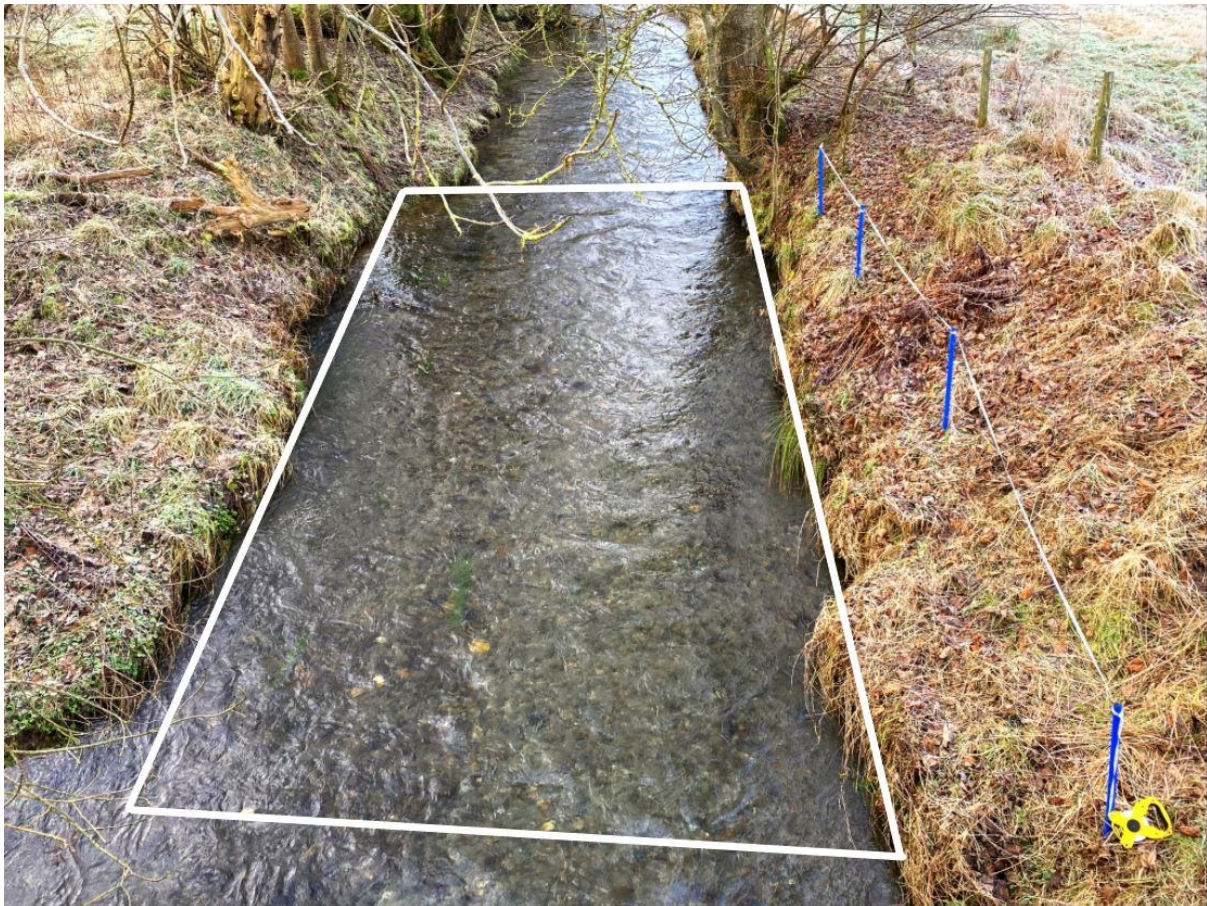
For 2025, the site at Chappel of Seggat on the main river has been selected following a site inspection of the spawning substrate which revealed it was heavily compacted with fine sediment reducing the quality of spawning substrate present. Despite an upturn in redd counts across the whole Seggat redd count reach during 2024, the location proposed would benefit from gravel washing, figure 5.

Figure 5. Chappel of Seggat, proposed site of compacted gravel delineated by white polygon.

<b>River/Tributary</b>	<b>Grid Reference</b>	<b>Activity</b>	<b>Time Scale</b>	<b>Job Description</b>
Chappel of Seggat	NJ 72793/42705	Gravel Jetting	6 days	Use leaf blowers to remove fine sediment, dig and rake gravel to improve spawning conditions.

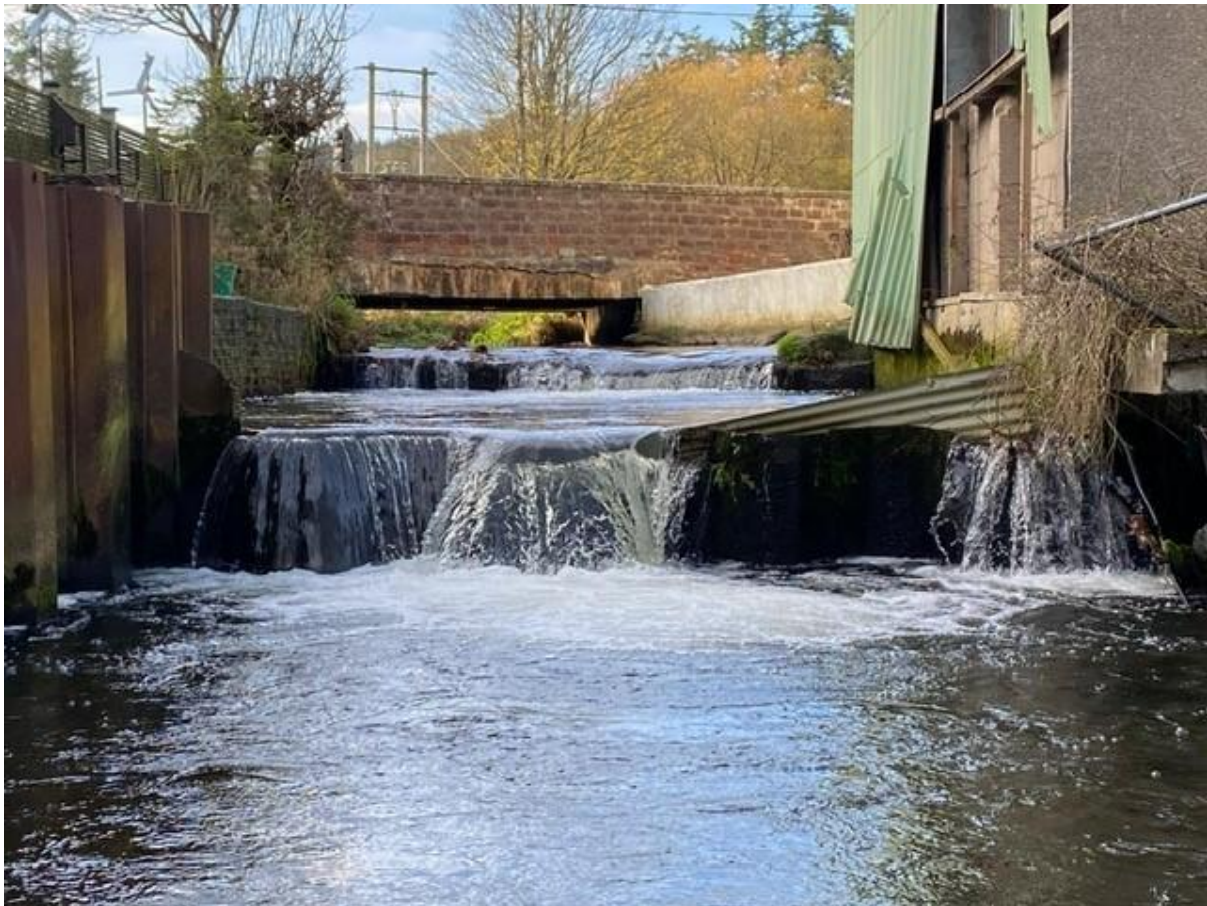
A two-stage sheet piling weir on the lower Fourdon burn by the village of Fyvie presents issues for fish passage during times of moderate to low flows. It is owned by Scottish Water and is designed to protect an asset which runs between the two structures.

The structure pictured in figure 6, is not maintained and with corrugated sheets protecting the outer wall of Fyvie garage having now fallen into the river presents a danger to fish as well as potentially obstructing passage further.

Figure 6. Two-stage sheet piling weir on the lower Fourdon burn by the village of Fyvie, owned by Scottish Water.

Resuming correspondence with Scottish Water would allow the Ythan DSFB to establish any timelines for interventions associated with this site.

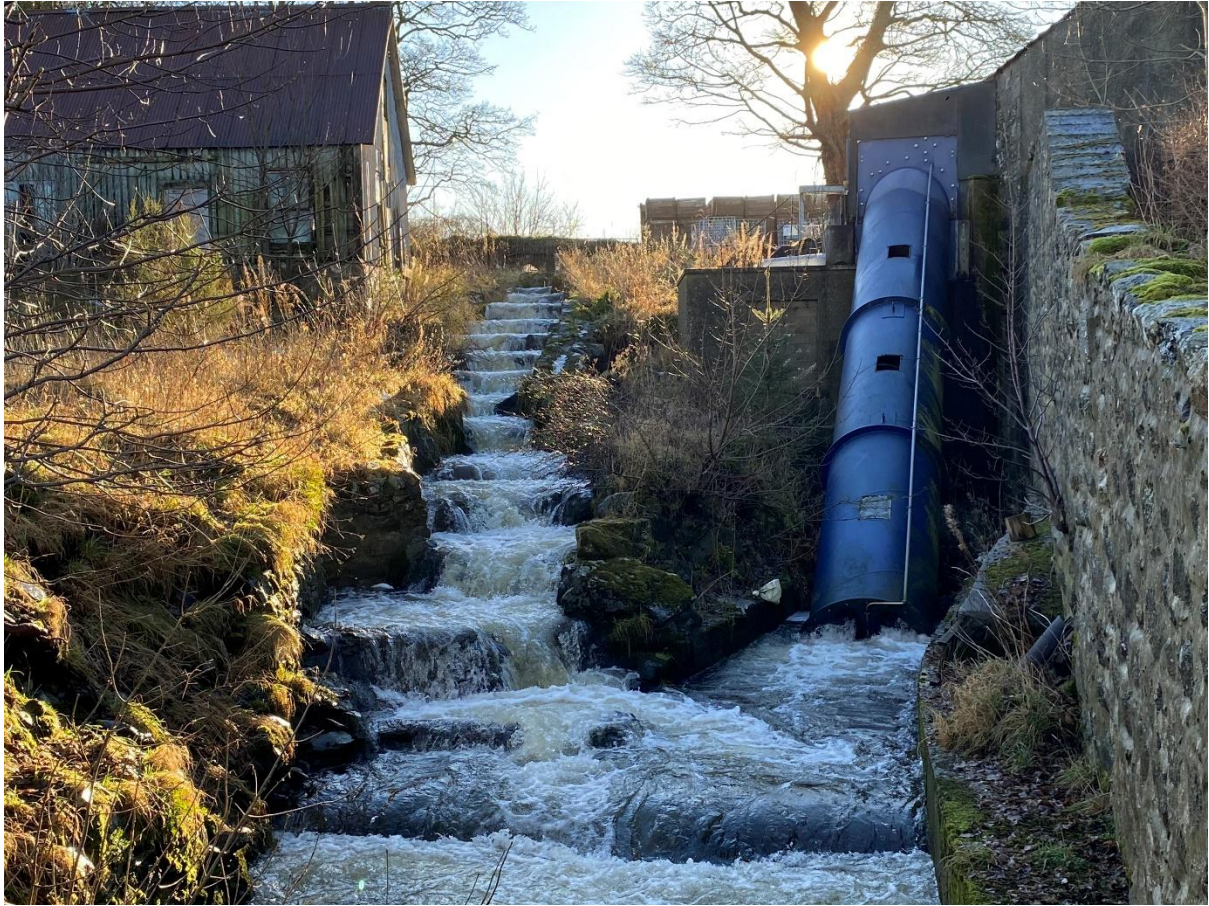
The fish ladder associated with the hydro scheme at Lady Anna Falls, on the Keithfield burn has raised concern for fish passage. The site is located a couple of hundred meters upstream from the confluence with the Ythan and is owned by Haddo Estate which was an early adopter of the micro hydro scheme movement in the late 2000's - 2010's. At the time of its installation regulators (SEPA) hadn't provided detailed guidance on these micro hydro schemes and the scheme was commissioned with the existing in situ step pool fish pass, figure 7.

Some concern was raised over the efficacy of the existing design given the number and size of the steps as well as the turbulent water present in each pool. Remedial works to the masonry of the existing fish pass was undertaken when the hydro scheme was commissioned but no material changes were made to the design and its efficacy.

Since 2018 the annual repeat redd count surveys undertaken through the SLA have not identified any salmon redds upstream of this site on the Keithfield burn. A single sea trout redd was recorded in 2018 at the site however we believe this to be a misidentification for a trout redd. Since that point only brown trout redds have been identified.

Figure 7. Lady Anna Falls step pool fish pass on left and hydro on right.

With this information to hand and the previous concerns raised around the efficacy of the fish pass for a range of species and sizes we would suggest that this is investigated further. Fish pass assessments using [SNIFFER](#) Coarse resolution rapid assessment methodology to assess barriers to fish migration can be undertaken which would help understand the pressures associated with the fish pass and present opportunities for further discussion. Reviews of historical data and surveys of fish and habitat upstream could also be considered to advance the understanding of the Keithfield burn and potential impacts on migratory fish access through the Lady Anna Falls Fish Pass.

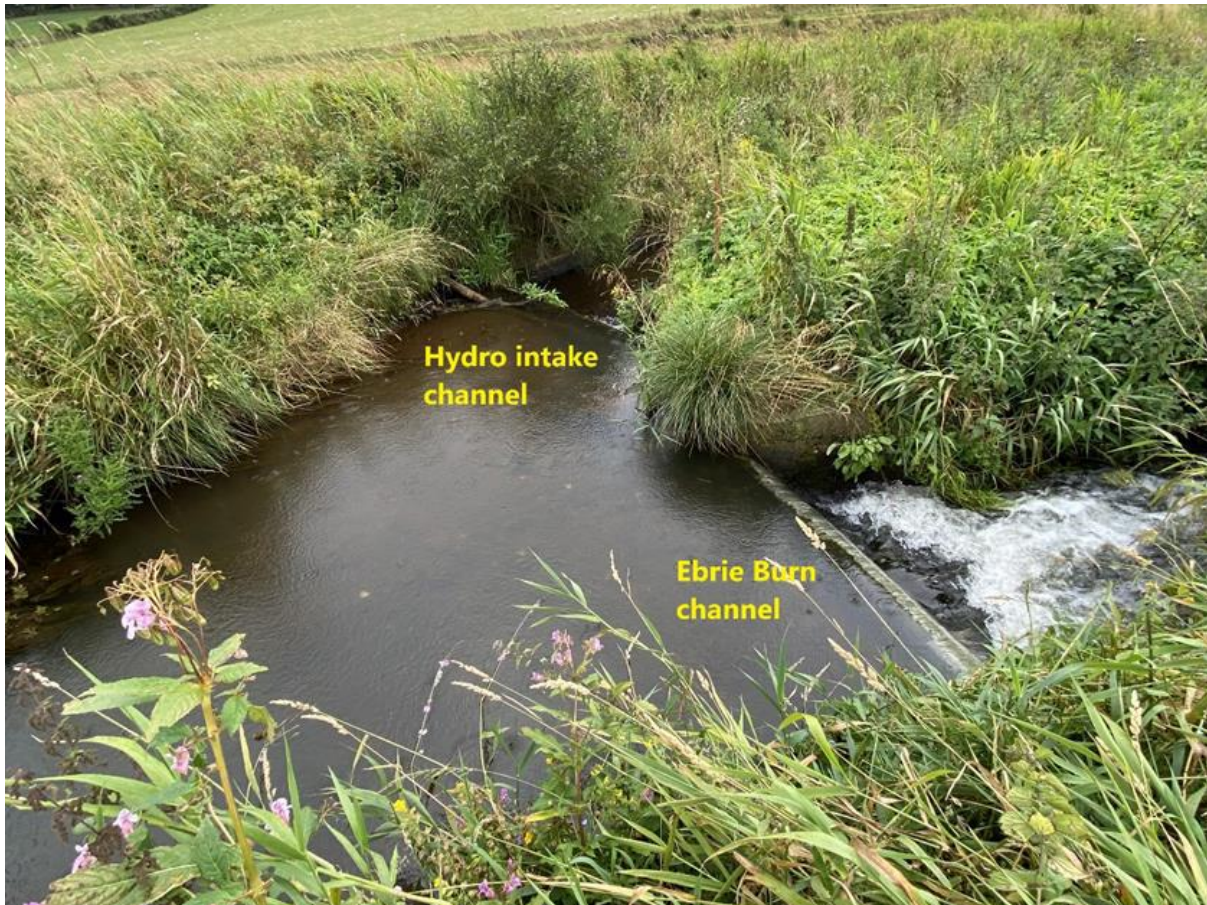
The now defunct Mill of Elrick Fishery and Hydro Scheme is still abstracting water from the Ebrie Burn. This has resulted in a depleted reach of approximately 900m on the Ebrie Burn posing issues for fish migration in both directions. The intake structure is poorly designed and has inadequate controls over the flows being abstracted, figure 8. The risk to fish being damaged as they exit over the spillway from the lade is also significant.

- Uncontrolled abstraction with no commercial activity.
- Extensive depleted reach 900m, with minimal flows in comparison to abstraction channel.
- Inadequate intake design.
- Current intake design in state of disrepair and at risk of failing, which could result inadequate flows through the Ebrie channel for the existing fish and aquatic life living in the depleted reach.
- Current intake design causing obstruction to fish passage on Ebrie channel, no notch placed in centre of boards.
- Lack of screens to prevent fish being drawn through the hydro scheme.
- No hands-off controls or measure indicator.
- Inadequate spillway design posing potential serious damage or death to fish.

Figure 8. Denoted channels on the Ebrie burn at the Mill of Elrick water abstraction site.

We would request that there needs to be greater control placed upon the abstraction by the regulators, SEPA. The potential damage, loss and delay caused to smolts migrating downstream in either channel currently is not acceptable and likewise for the issues surrounding upstream passage of salmon and sea trout with reduced flows through a depleted reach of 900m. Given there is no economic activity associated with either structures (the hydro and fishery) this should result in action in a much quicker timeframe.

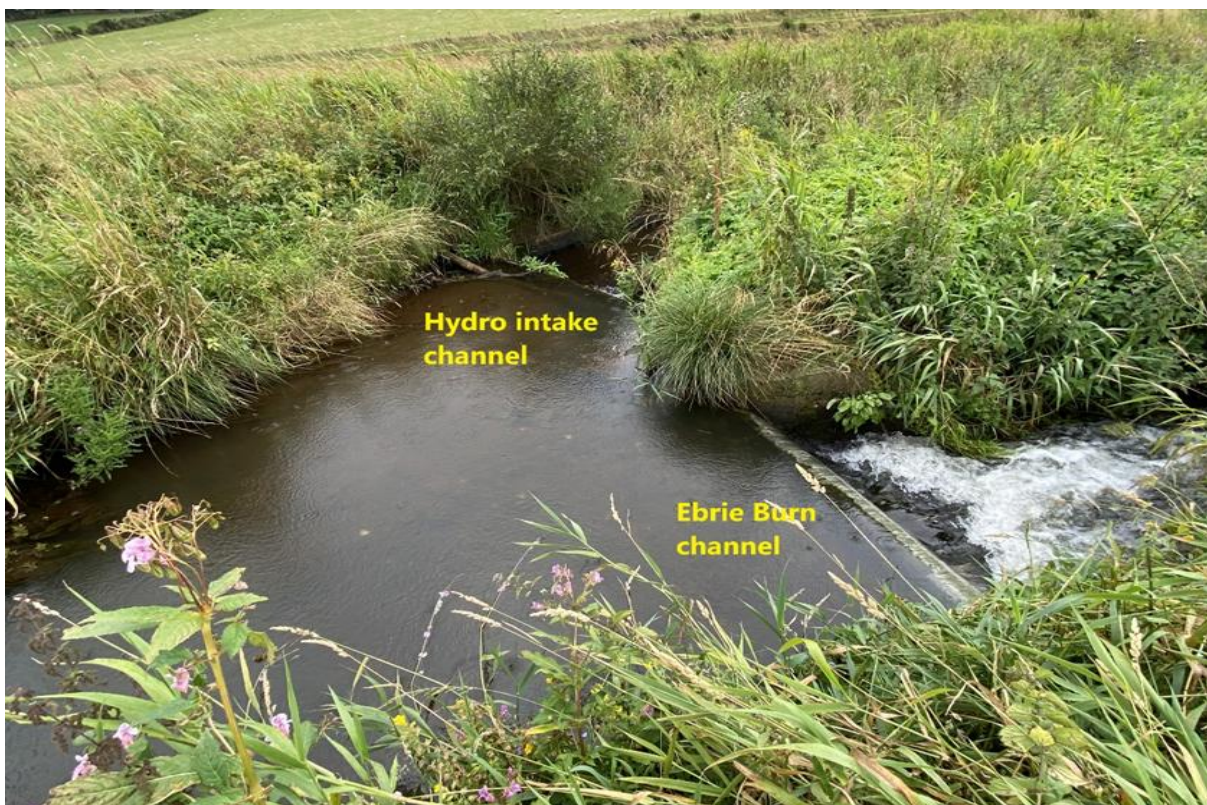
The right channel feeds the depleted section of the Ebrie burn, and the left channel feeds the abstraction intake, for the now defunct Mill of Elrick Fishery and Hydro Scheme. Figure 1 below showing the two channels in question.

Fig 1. Denoted channels on the Ebrie burn at Mill of Elrick water abstraction site.

The now defunct Mill of Elrick Fishery and Hydro Scheme are still abstracting water unnecessarily currently. This has resulted in a depleted reach of approximately 900m on the Ebrie Burn posing issue for fish migration.

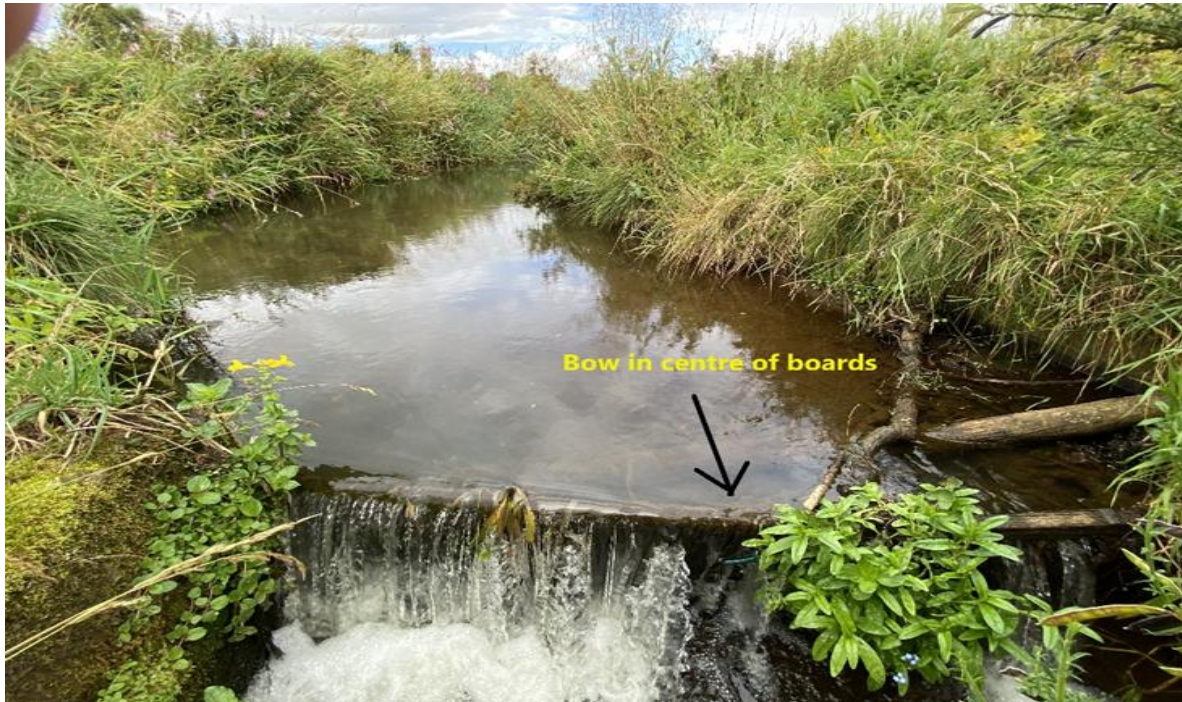
The intake structure is poorly designed and has inadequate controls over the flows being abstracted. At the top of the Hydro intake channel there are two thin wooden boards which have been placed to check the flow. Pressure from behind the boards has caused a noticeable bow in the centre, the boards also show signs of decay and are at risk of failing. If these boards were to breach, it will result in most of the water being drawn into the abstraction channel, leaving very little flow if any down the depleted channel of the

*Ebrie burn. This would be devastating for the fish and invertebrates in the depleted Ebrie Burn. See figures 2 & 3 below of the two boards in question.*

*Fig 2, above showing bow in centre of boards at top of abstraction channel*

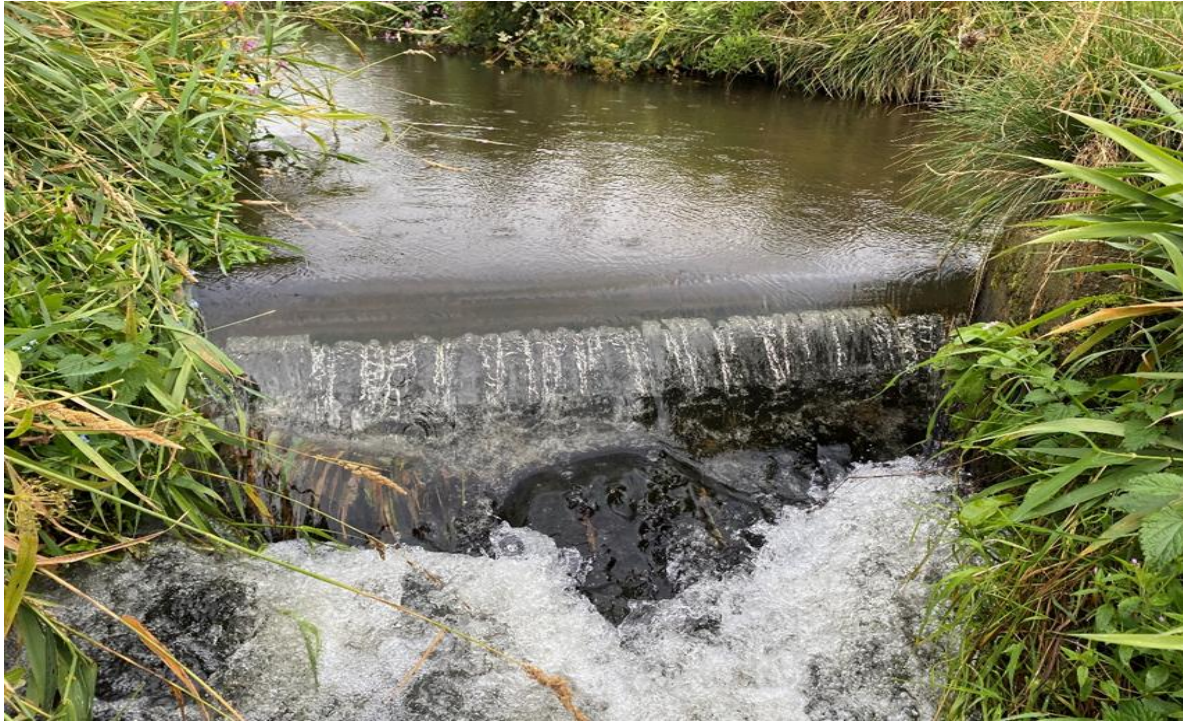
*On the Ebrie channel there are also wooden boards that have been placed, these boards have no notch in the centre to allow fish to freely ascend over this obstruction.*

*Fig 3. Below showing boards placed at the top of the Ebrie burn channel causing obstruction.*

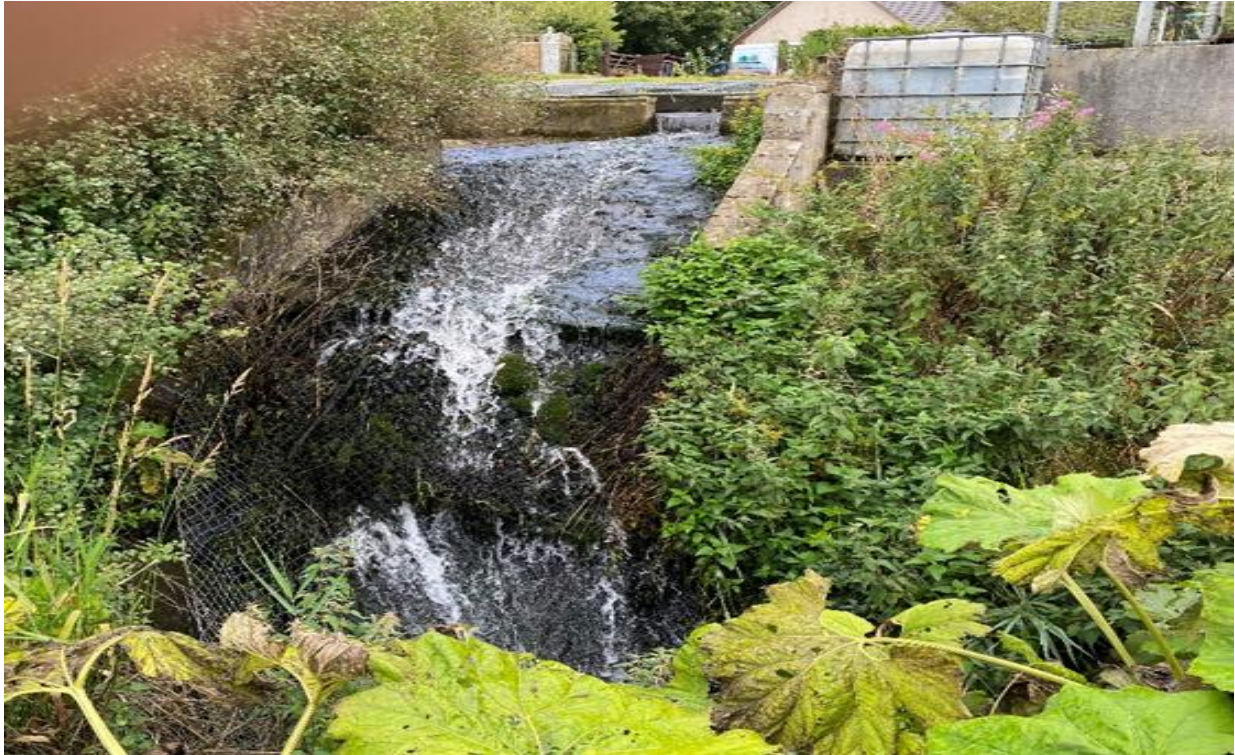
*Approximately 900m further downstream is a spillway where water exits from the hydro scheme lade. This is a very steep decline with rocks at the bottom and wire mesh on the face. Salmon and sea trout smolts migrating downstream through the hydro scheme lade, have to exit over this spillway which could possibly cause serious injury, entrapment or death, figure 4.*

*Fig 4, Spillway from hydro scheme.*
