River Ythan SLA Report November 2023 to January 2024

Archimedean screw Hydro Mill of Elrick, Auchnagatt

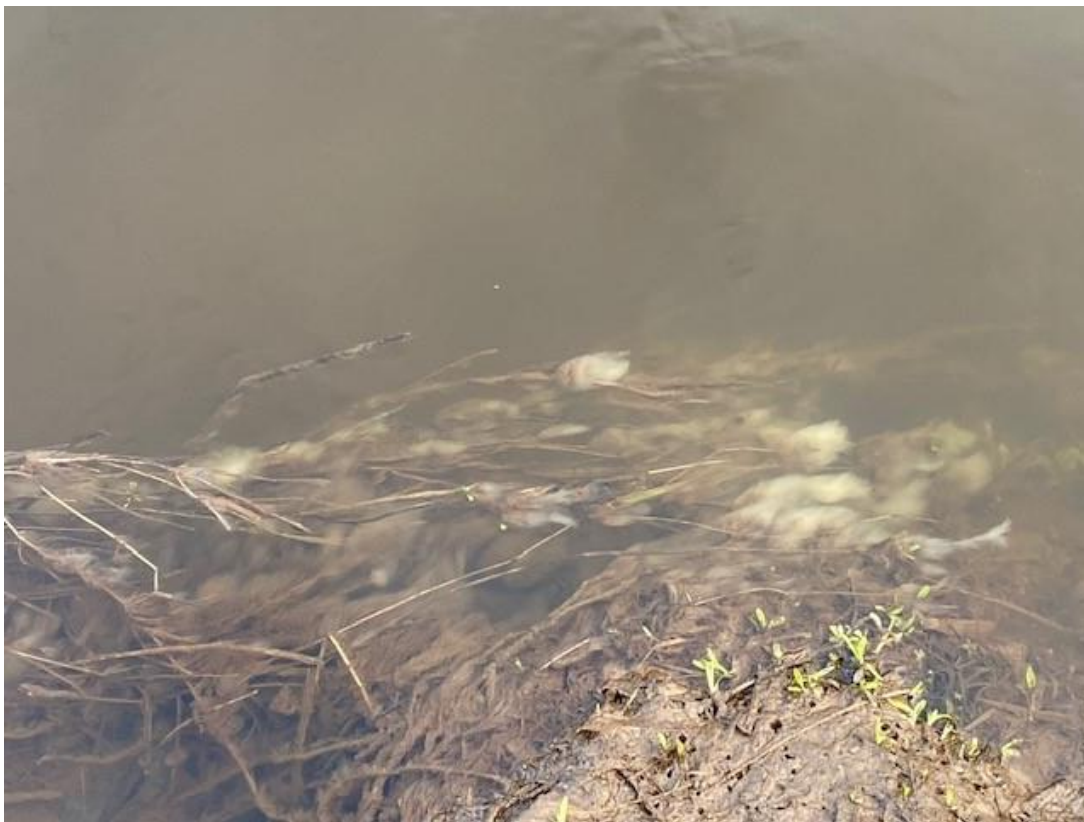
On the 9th of January a white fungus was identified in abundance clinging to vegetation instream on the Ebrie burn below the village of Auchnagatt. A very large area had been affected with what looked like sewage fungus. Pictures were taken and sent to SEPA Inspector Mark Gracey, of the Grampian and Speyside team for investigation. I will keep the Board updated on this incident when further information becomes available.

Fig 1, white fungus on vegetation below

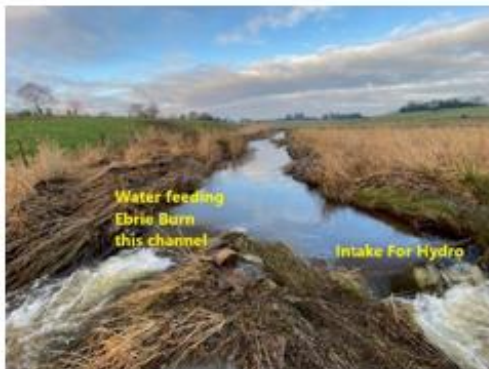
- Firstly, there did not seem to be any appropriate means of abstraction control, whereby the volume of flow into the hydro lade can be regulated in any way, or when the hydro is not in operation the lade cannot be shut off. The only means of control evident were crudely designed submerged wooden structure at both the intake and main Ebrie channel, see in Fig 5, 6. Clearly there needs to be better regulation of this abstraction at the point of intake.

Fig 2, upstream view of Hydro intake.

We would suggest following this matter up with SEPA to ascertain whether the hydro scheme is operating within its licence conditions. We have already reported this matter informally to SEPA Grampian team whilst discussing other issues, however, it would be best to have some formal communication directly from the Board on this matter.

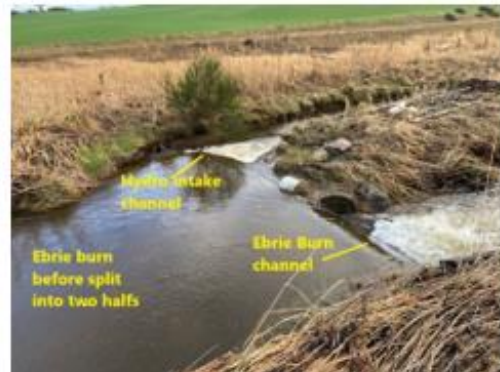
Fig 3, Downstream of Hydro intake.

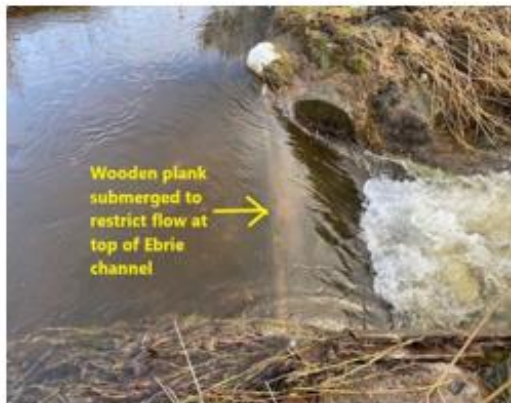
Fig 4, Note Submerged Wooden plank in Ebrie channel restricting flow

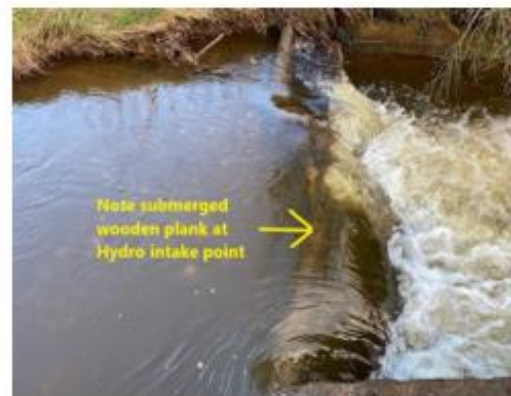
Fig 5, Note submerged wooden plank at intake to Hydro.

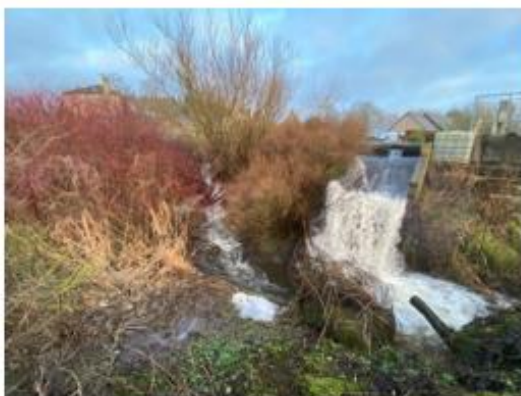
- When the hydro is not abstracting the uncontrolled flows are still passing through the hydro lade and over the spillway approximately 1km below the abstraction point, see Fig 6. There are concerns over the ability of migratory fish to descend the through the spillway safely and without risk of a significant delay to their migration or worse still potential damage.

Fig 6, Water Exiting Hydro lade over slip way.

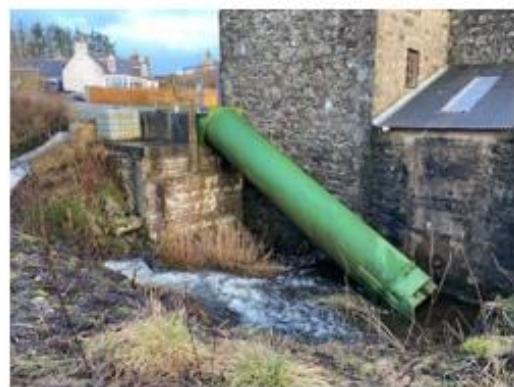
On the 9th of January while carrying out survey work on the Ebrie burn on the section of stream below the village of Auchnagatt, I came across the intake for the Archimedean screw hydro at the Mill of Elrick. There were several concerns that came to my attention while examining this intake, please see pictures below. It was noted that the hydro was not operating despite there being adequate flow. (Further to this it has come to our attention that the hydro has not been operational for some time).

Fig 7, Archimedeian screw not in use.
