KEITHFIELD BURN FISH PASS AT KEITHFIELD LAKE.

The Keithfield Burn is one of the two main tributaries of the Kelly burn which flows through the Haddo Country Park.

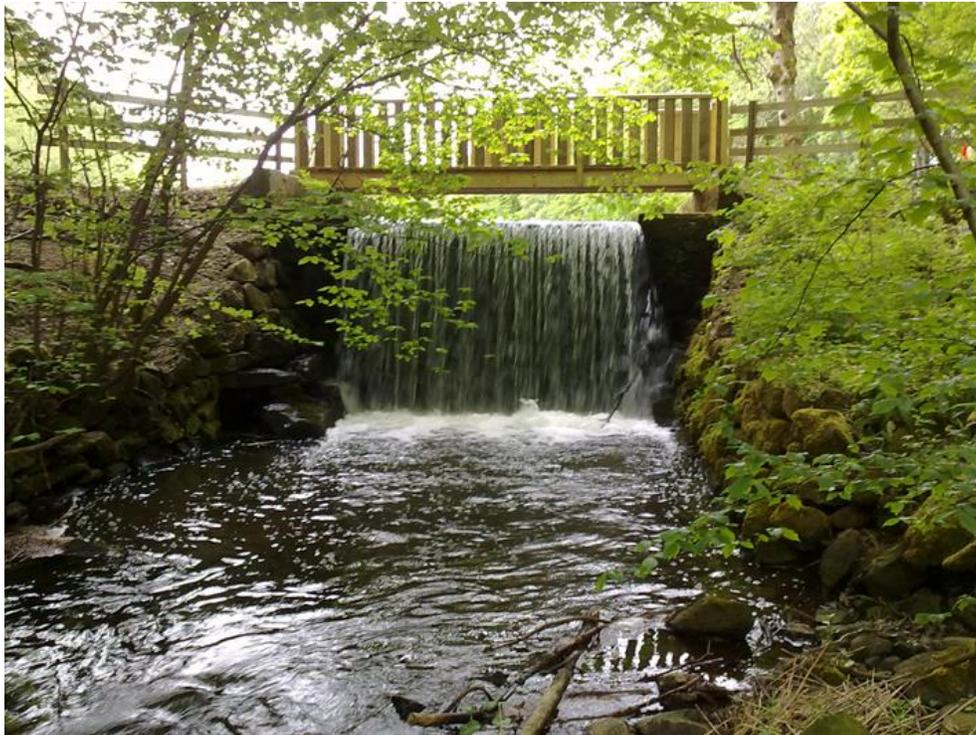
Keithfield Burn Main Outlet. 2012. Impassable Falls.

We very briefly considered the installation of an Alaskan A Denil fish pass; however, the cost would have been in excess of £30000.00, therefore this option was immediately discarded.

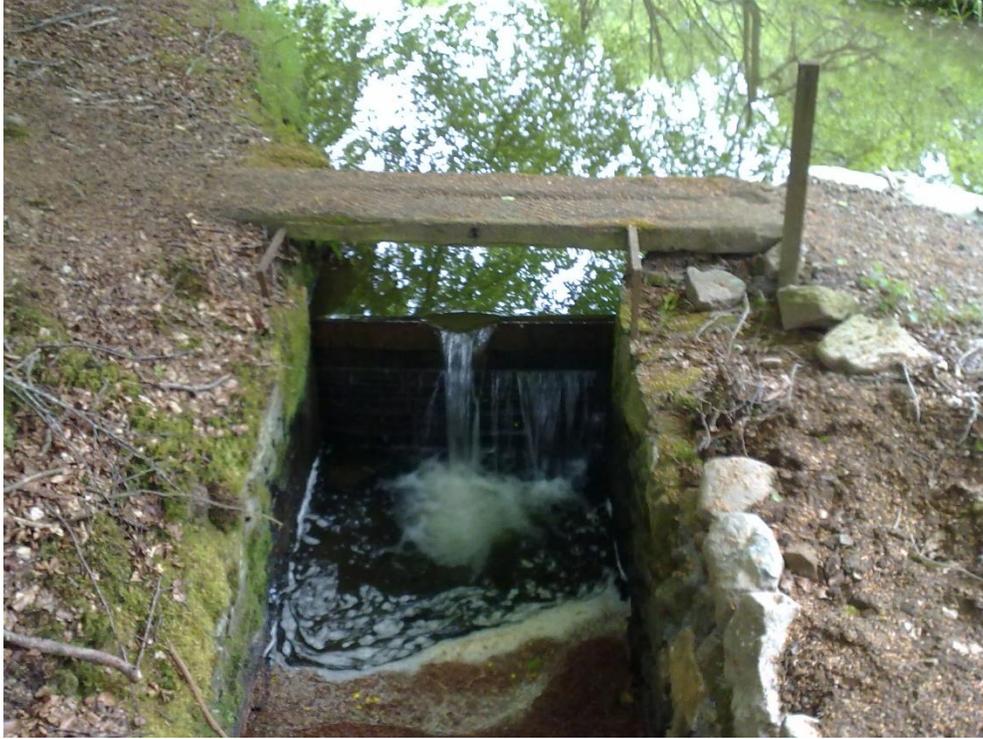
Keithfield Burn Top Weir. 2012. Shows the sluice. Insufficient Water Going Down the Channel.

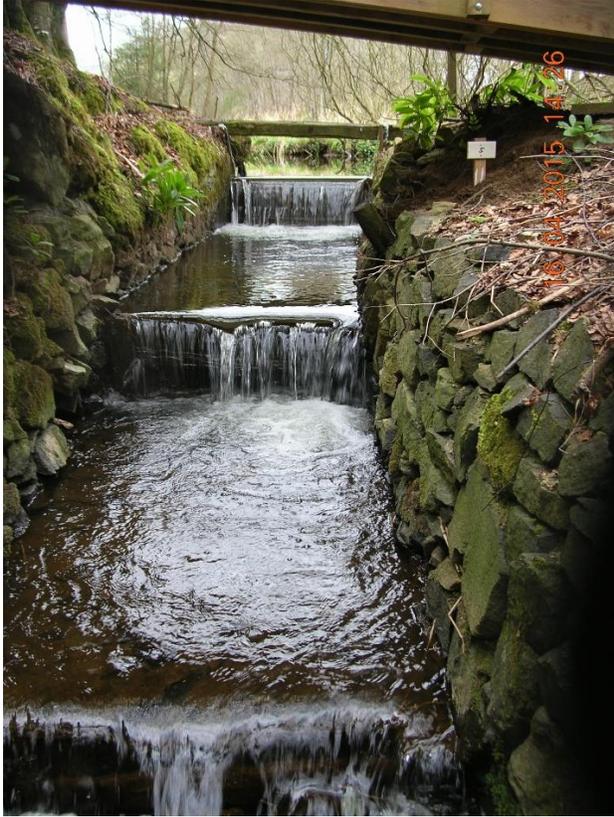
The left hand photo below shows an upstream view from about 10 metres downstream of the top weir. The top weir (sluice) has a head height of around 420 mm – the height a fish has to jump, and a water depth below of around 450 mm, unfortunately, for a pool and weir fish pass for trout the head height should not exceed 300 mm, ideally 200 mm. The water depth below the second and third weirs were so shallow that trout would not be able to gain sufficient speed to jump the weirs.

Secondary Outlet 2015.

The solution arrived at was to install a sufficient number of weirs with staggered slots to increase both the water depth to a minimum of 300 mm and to provide resting places between the weirs for trout to recover whilst on their upstream journey. Due to the small head height between weirs, around 200 mm, most of the time little fish jumping will be required.

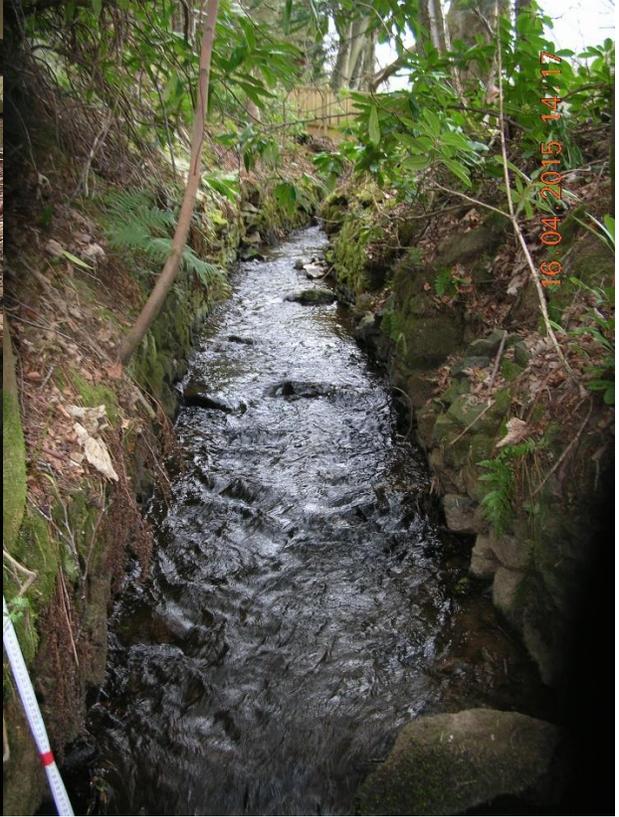
The right hand photo shows an upstream view of the channel from about 30 metres downstream – note the partial collapse of the bank on the right hand side, but most importantly the depth of the water – 10 metres from the top weir down to the bottom of the 70+ metre channel, the water depth averaged 176.5 mm, the smallest depth recorded was a mere 110 mm.

Secondary Channel 2015. (Note the part collapsed wall).

The construction was carried out by Mike Stewart and Jim Adie, both experienced builders and Trust Directors, working as volunteers – firstly Mike rebuilt the collapsed side wall of the channel. then together they built the weirs using steel rebars fixed into the channel walls, the timbers for the weirs fixed onto the rebars – pointing was used to complete the fixing into the channel walls and in a few places the channel walls were heightened. The lowest part of the channel at the confluence with the stream from the main outfall was adjusted using boulders found on site to create suitable access for migrating fish.

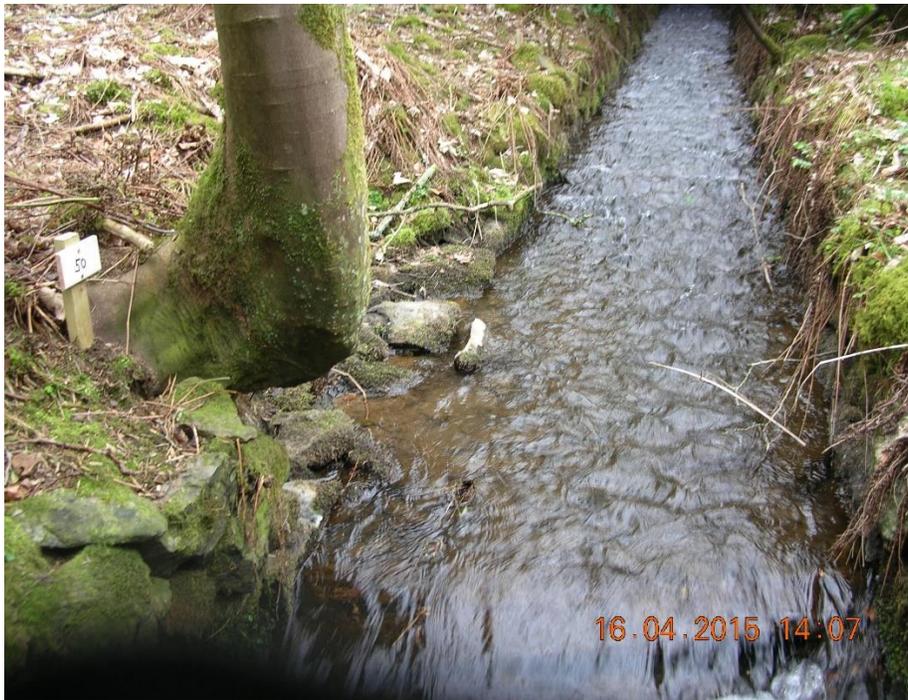
Secondary Channel Upstream View. 2015. 50 Metres Below the Top Weir.

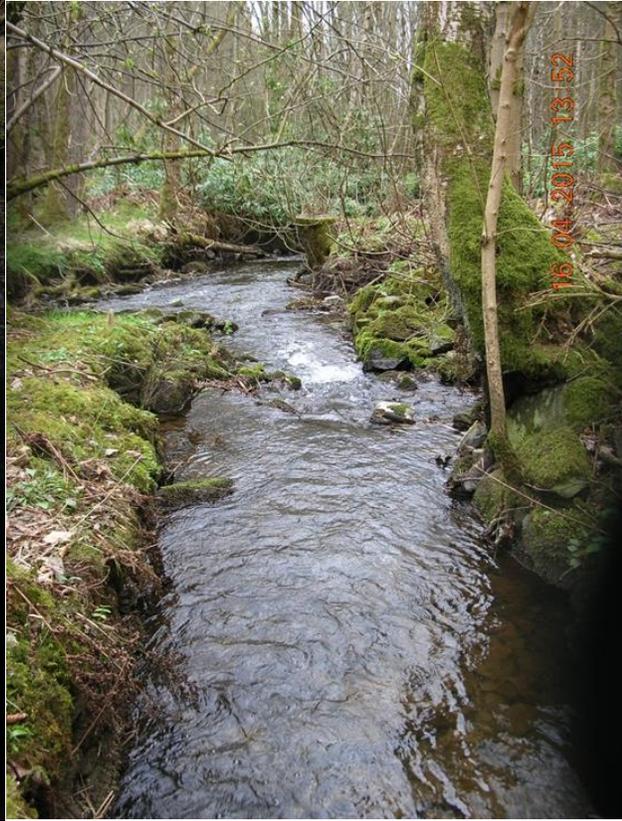
Secondary Channel. 2015 Downstream Junction.

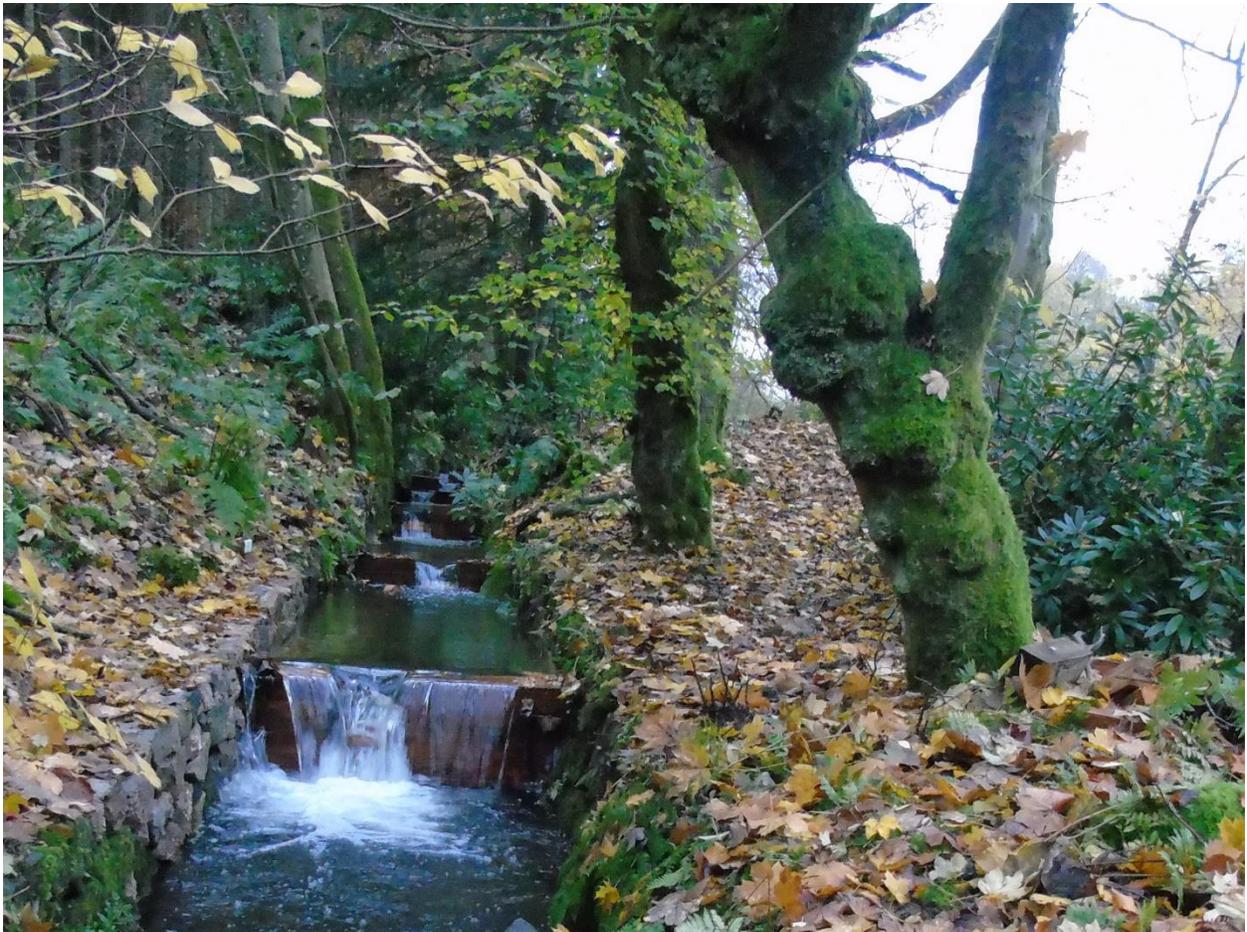
Project Nearly Complete. View Upstream Early November 2018
