# YTHAN DSFB HABITAT IMPROVEMENT PLAN 2023

*Draft for Approval*

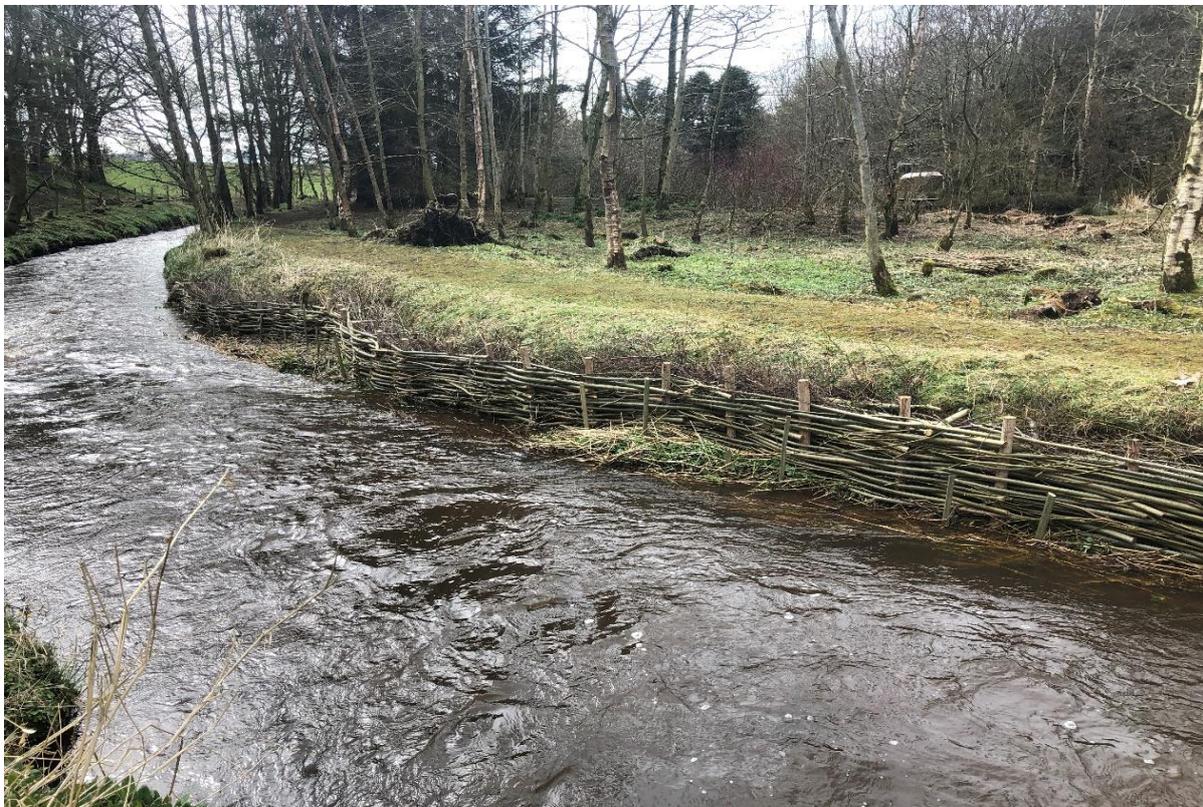
Figure 1, Willow bank repair on the Ebrie, March 2022.

The site on the Ebrie Burn is only a short distance above where 8 salmon redds were identified in November 2022, 4 of these redds were directly below the new willow bank repair carried out in March 2022, Figure 1 & 2. To keep the habitat in good order for returning adult spawning fish, further remedial work would be beneficial. The bank upstream requires further repair because of areas of collapse and undermining. Large sediment deposits are entering the watercourse and settling at the salmon redd sites below. Figure 3 & 4.

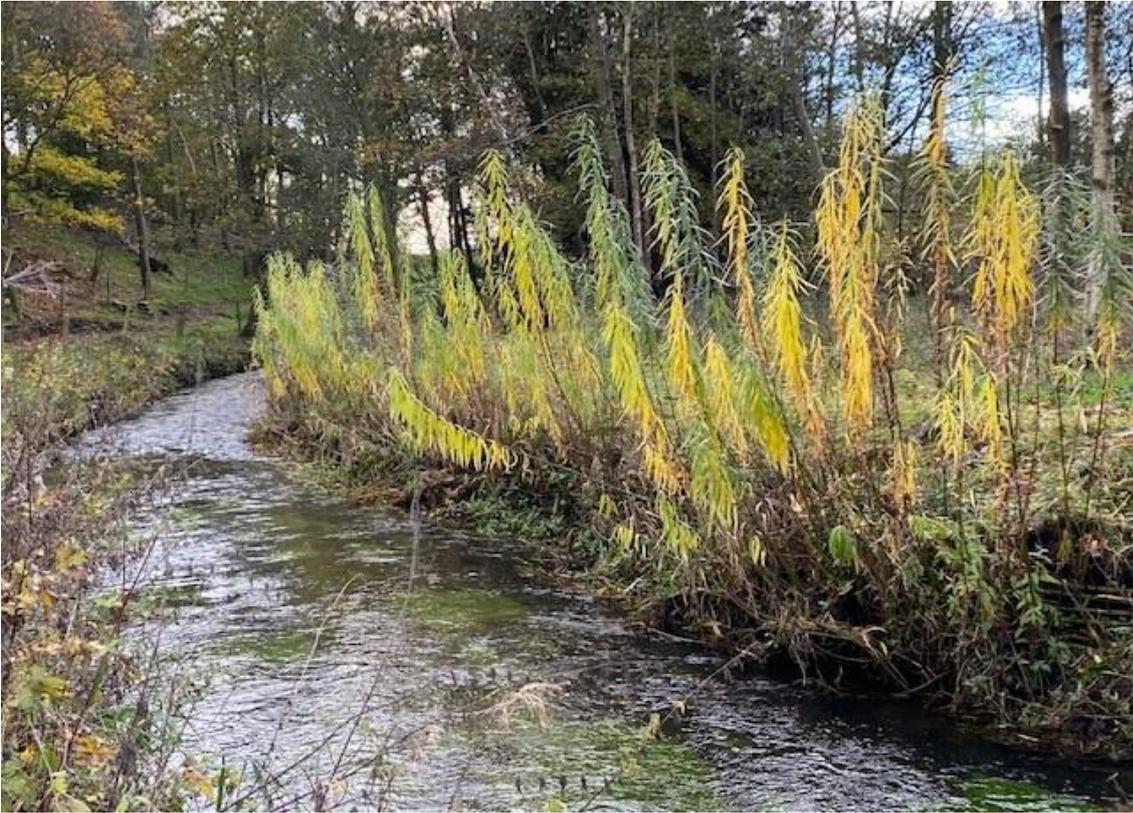
Figure 2, Willow growth after only 7 months from completion.

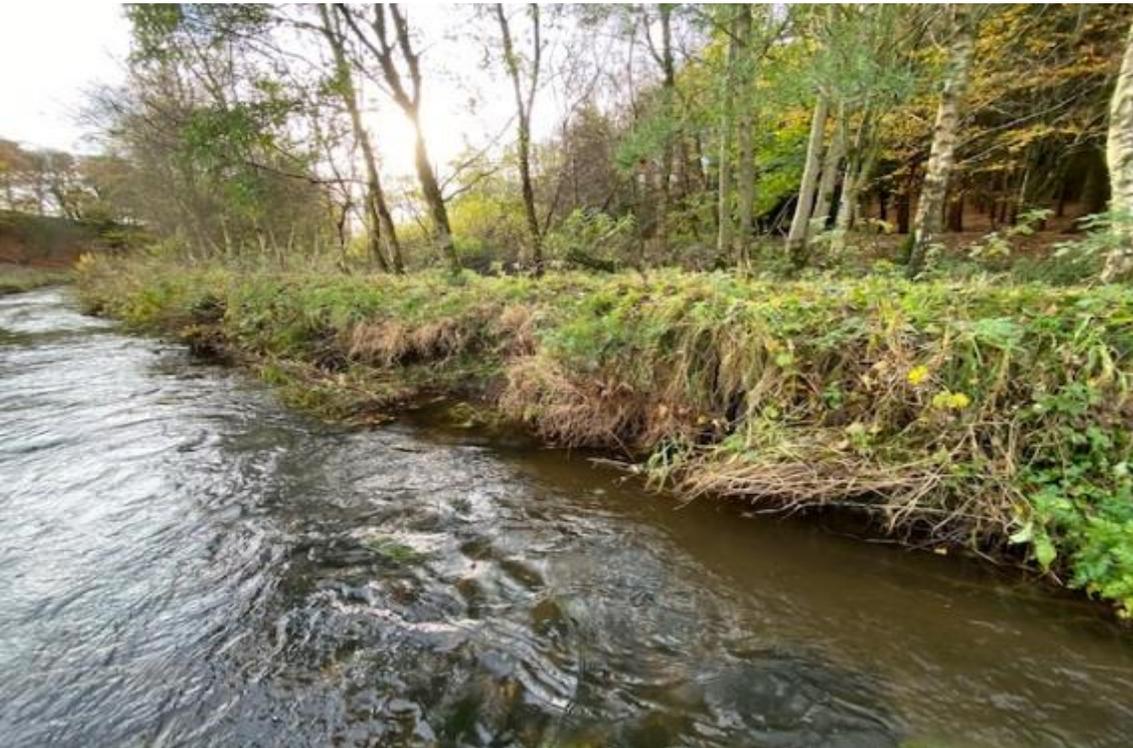
Fig 3, 10m section on the Ebrie that has become unstable and undermined with a section now collapsed.

River/Tributary	Site Name	Grid Reference	Length of Repair	Job Description
Ebrie Burn	Glen Ebrie	NJ93590 40270	10 meters	Drive willow posts along face of bank erosion, weave willow canes between. Fill between bank and weave with woody brush. Estimated time 6-man days 2 staff

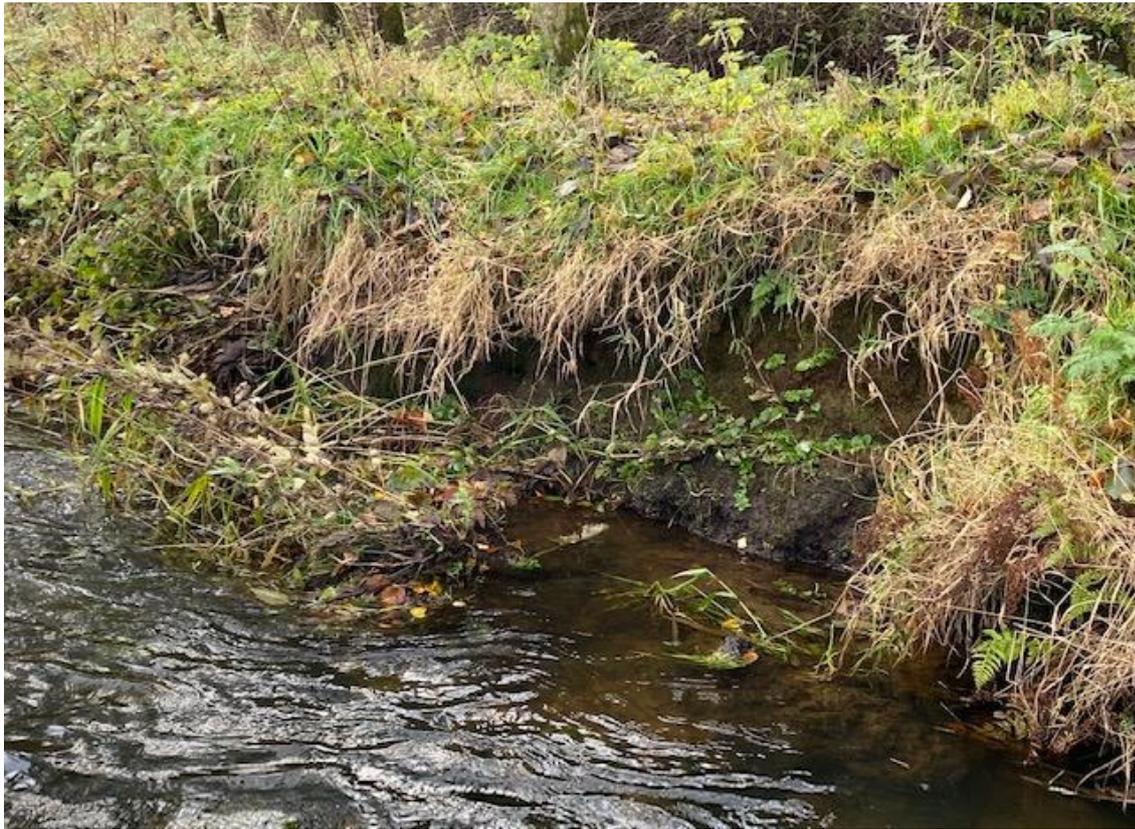
Figure 4, Ebrie burn, collapsed section below.

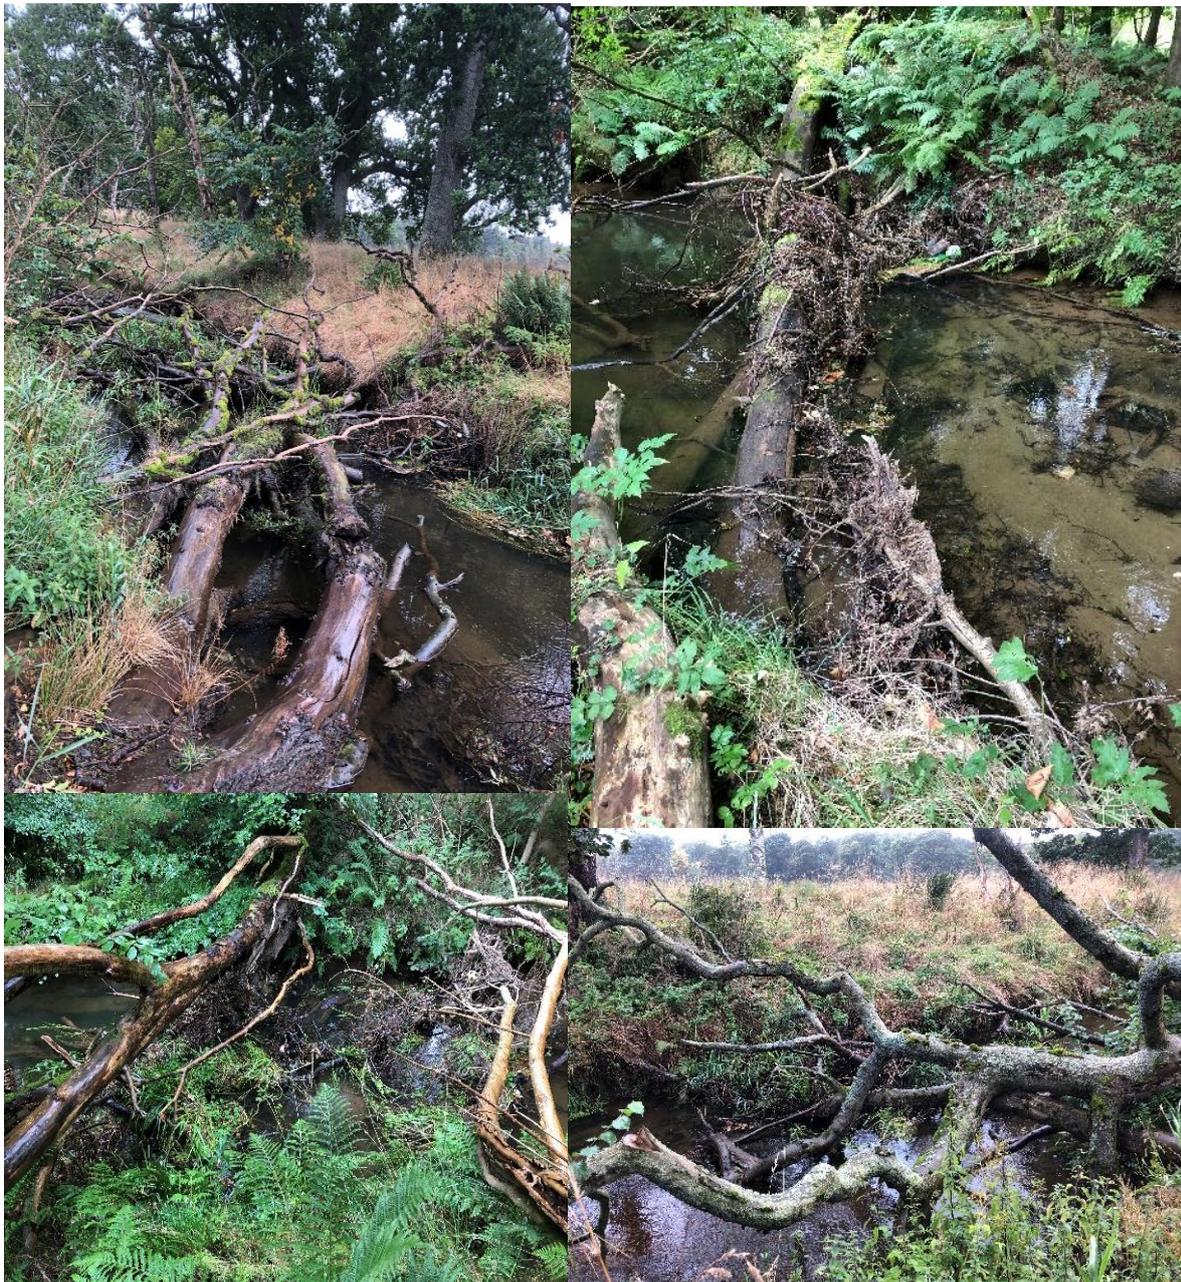
Figure, 5 Fallen trees on Fyvie Estate.

In total five separate potential obstacles have been identified, Figure 5. It's anticipated that by the time these works take place, the structures will have increased in complexity in terms of the challenge posed to fish passage and there may also be new structures within this reach. Therefore, we have allocated resources accordingly to this task.

River/Tributary	Site Name	Grid Reference	Job Description
Fyvie Estate	Opposite home farm	NJ 76322 40245	Monitor LWS at key periods of fish migration to ensure passage, intervene where required. Estimated man days x 2 staff 6

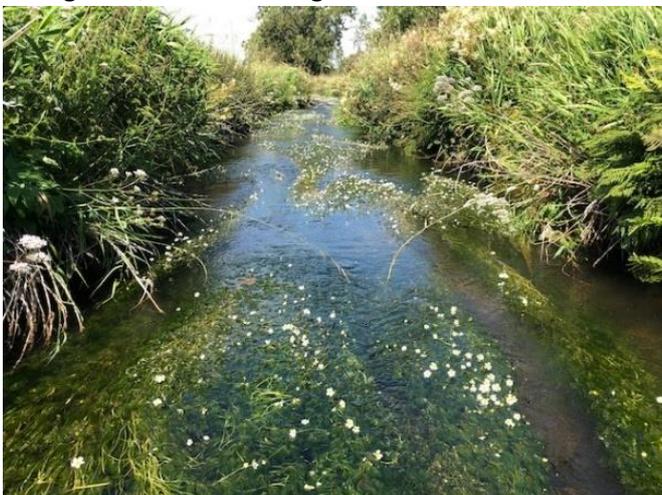
Figure 6, Before cutting

The removal of this aquatic weed when targeted at key points within the catchment can help improve the availability of key habitat types, such as spawning substrate. The Ythan catchment and the Ebrie Burn suffer from an excise build-up of fine sediments from existing land use and underlying geology. In the Ebrie Burn coupled with historical canalisation, this results in a very uniform channel with limited habitat diversity and poses problems for suitable spawning substrates, Figure 6-9.

The cutting and clearing ranunculus are activities targeted at suitable spawning substrate on the Ebrie Burn, particularly those at risk of being impacted by the plant as described above. Please see images of works carried out in 2022.

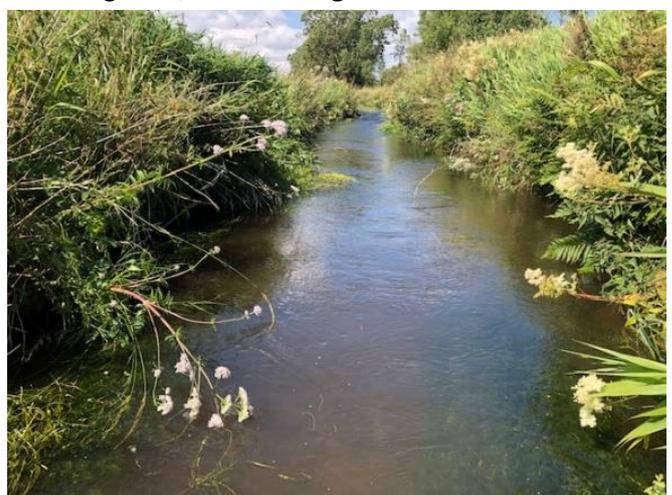
Figure 7, After cutting

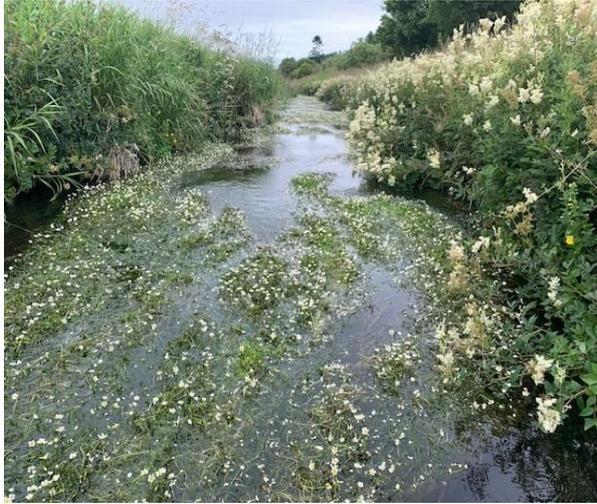
Figure 8, Before cutting

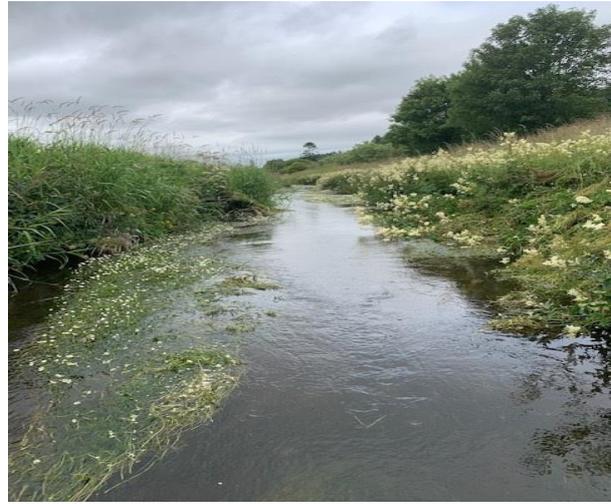
Figure 9, After cutting
